Instrument Calibration Chart

Manifold Pressure - Rear Console

Piper Saratoga N22UT

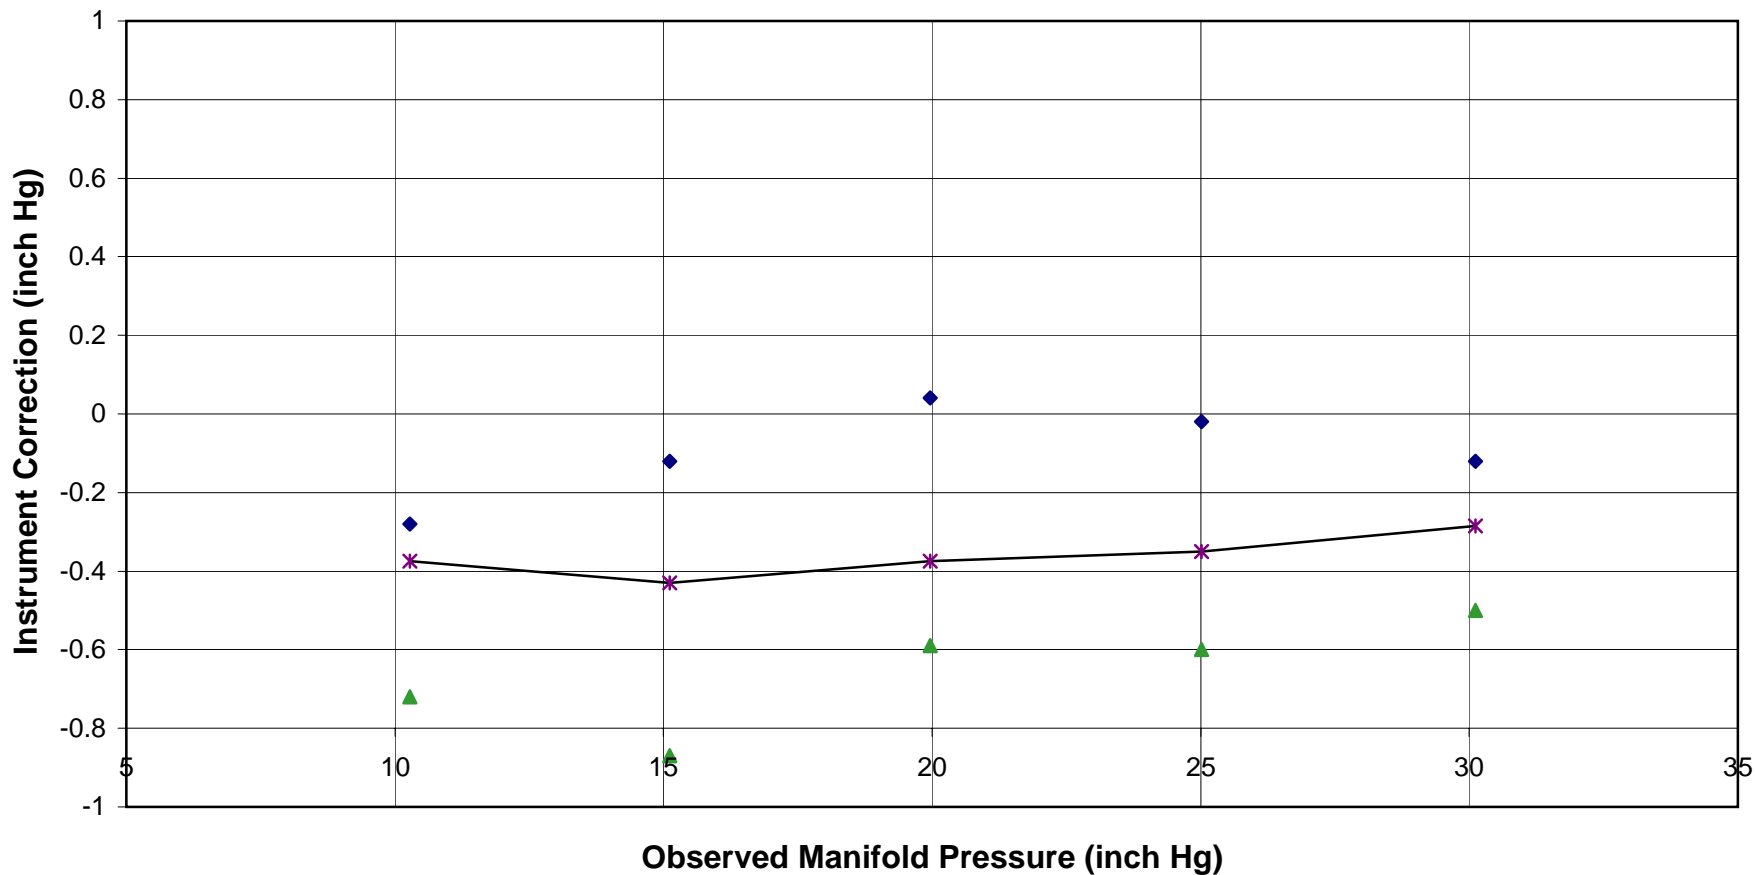
- ◆ Increasing
- ▲ Decreasing
- *— Tapped Value
